**Inspection of Demonstrator  
Bonded Repairs on a  
QANTAS 747-300: September 1999**

DSTO-TR-0900

**Airframes and Engines Division**  
Aeronautical and Maritime Research Laboratory

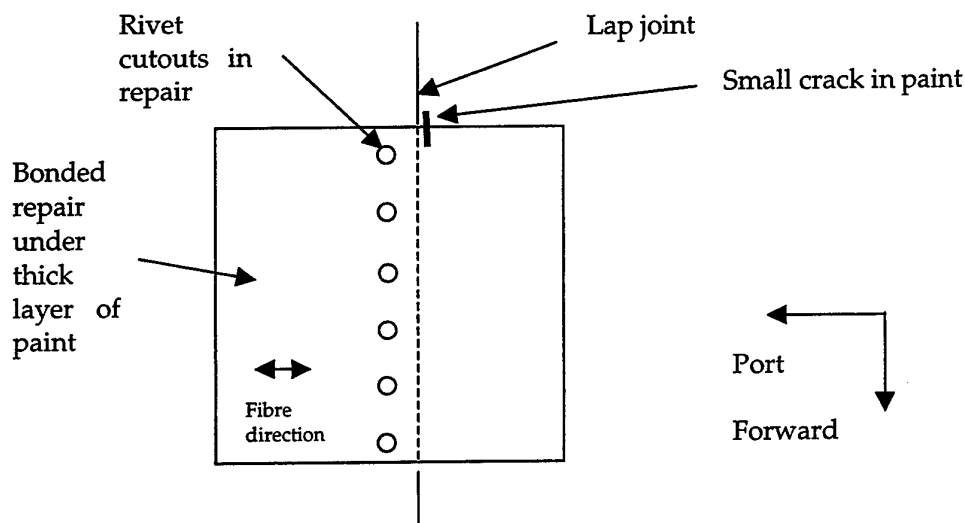
Inspection of this repair proved difficult, as there was a thick layer of paint over the repair. Tap test and visual inspection showed no signs of degradation of the repair. There was a small crack in the paint at the aft edge of the repair running in the longitudinal direction as shown in Figure 2.

Figure 2. Orientation of repair at location 'a', showing crack in paint.

The crack in the paint at location 'a' was possibly due to movement at the junction of the lap-joint seams and the repair. A full inspection of this repair was not possible due the thickness of the paint in the region. The condition of this repair will be determined at a later stage after removal of the paint.

7. The demonstrator repair at location 'a' should have the paint removed from over it to allow for a more thorough examination of the crack location and to confirm whether or not it was a crack in the repair or a defect in the paint.
8. The demonstrator repairs at locations a, c and d should remain in service and be inspected at regular intervals. Should they start to degrade they should also be removed from the aircraft.

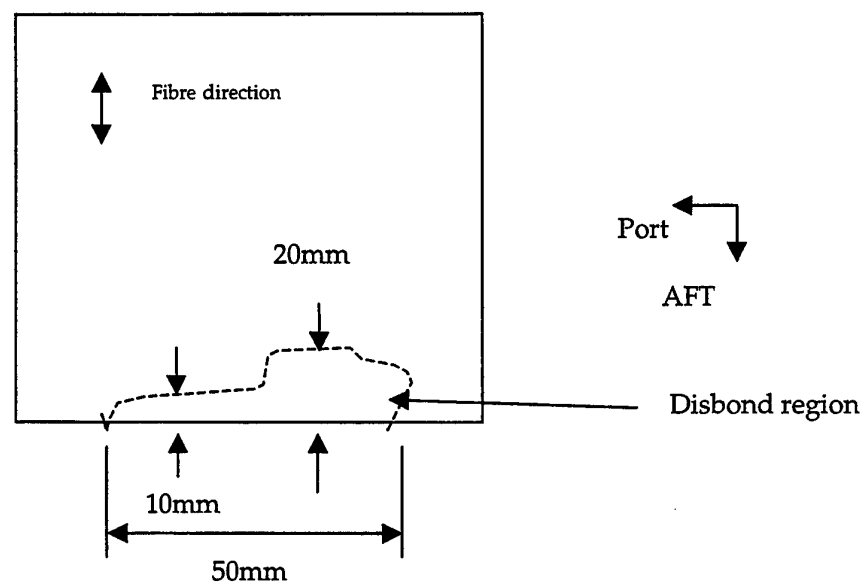
Visual inspection showed that the repair was in excellent condition, with a small crack in the covering-coat of paint along the width of the repair at the trailing edge. A tap test suggested that the repair had disbonded along this edge to a depth of approximately 20mm. There were no signs of erosion or impact damage. The aluminium skin in this region was rather flexible, with no support structure underneath. The map of the disbond indication is shown in figure 3. Photograph 1 shows the repair on the aircraft and the region in question.

Figure 3. Disbond map for repair 'b'.

At this time it was difficult to ascribe a reason for the disbond at location 'b' as there were no signs of erosion to the repair. It is possible that this disbond may have been caused by acoustic vibration causing fatigue in the adhesive. The indication could be of a disbond due to adhesion failure, however this would be unlikely as the condition of repair 'a' which had the same adhesive/cure system as 'b' exhibited very good durability with no indications of disbond due to adhesion failure.

The acoustic fatigue could have been caused by unsteady airflow over the top surface of the wing and flap while the flap segments were deployed. Confirmation of the disbond size and cause can only be determined by the careful removal of a segment of the repair for fractographic analysis.

5. The demonstrator repairs at locations b, e and g should be removed before they degrade to a level where they may compromise the safety of the aircraft or the personnel working on the aircraft. These particular repairs have proven their durability through prolonged service and it is doubtful that much more information could be gleaned by leaving them on the aircraft.

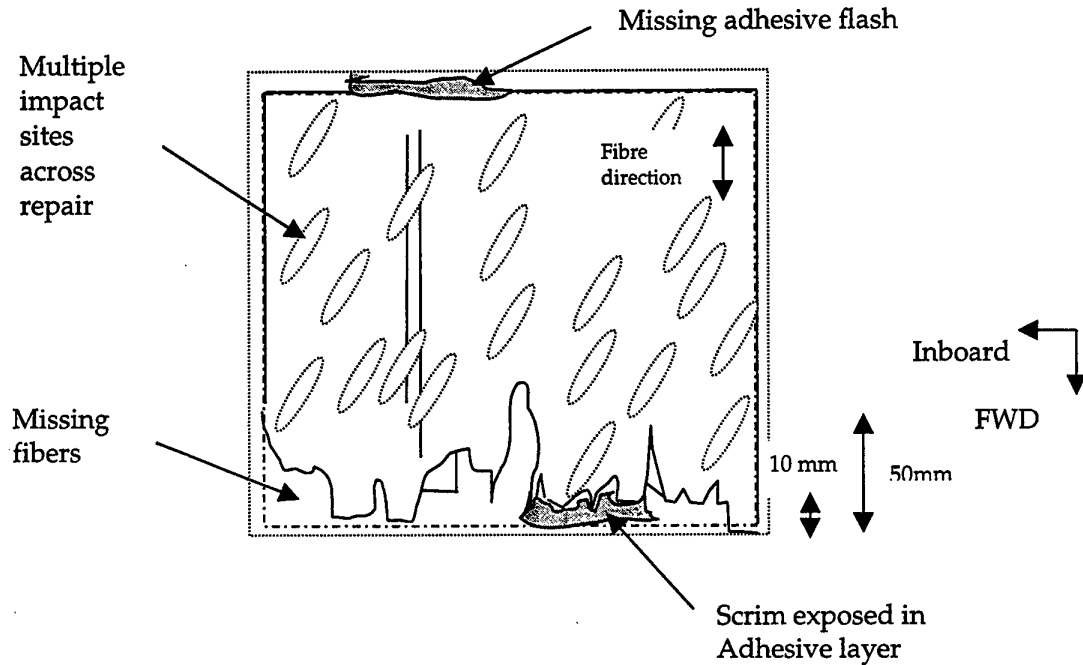
This repair showed significant erosion damage to the leading edge and top surface. There was evidence that the repair had been repainted many times during the life of the repair.

The main erosion damage was present at the leading edge of the repair. Within the first 12mm from the leading edge, most of the repair was eroded away, leaving traces of primer and adhesive only. The remaining ply damage extended up to 50mm back along the repair. The carrier scrim in the adhesive and the aluminium substructure was exposed in some areas, with some fibre tearout along the entire length of the repair. Damage on the leading edge of the repair effected all 4 plies.

Erosion had removed the adhesive and the primer from the areas where the aluminium surface was exposed due to lost fibers.

The second type of damage was at 45 degrees to the direction of the fibers, where foreign object damage (FOD) had caused paint stripping and damage to the surface of the repair as shown in photographs 2 and 3. On the rear edge of the repair part of the adhesive flash was also missing.

Despite the extensive damage and erosion, the bond integrity remained excellent with no abnormalities detected during the tap test.

Figure 4. Damage due to erosion and impact on location 'e'. Bond integrity was excellent across remaining areas of repair.

The source of the impact damage to the repair at location 'e', the leading edge of the wing, was most probably due to material being thrown up from the nose wheels

during landing and takeoff manoeuvres. This was characterised by the angle of the FOD markings on the repair that traced a direct line between repair and nose wheel bogey.

The only reason the repairs at locations e and g should be left on the aircraft is for the trial fitment of an erosion protection shield for in service effectiveness trials.

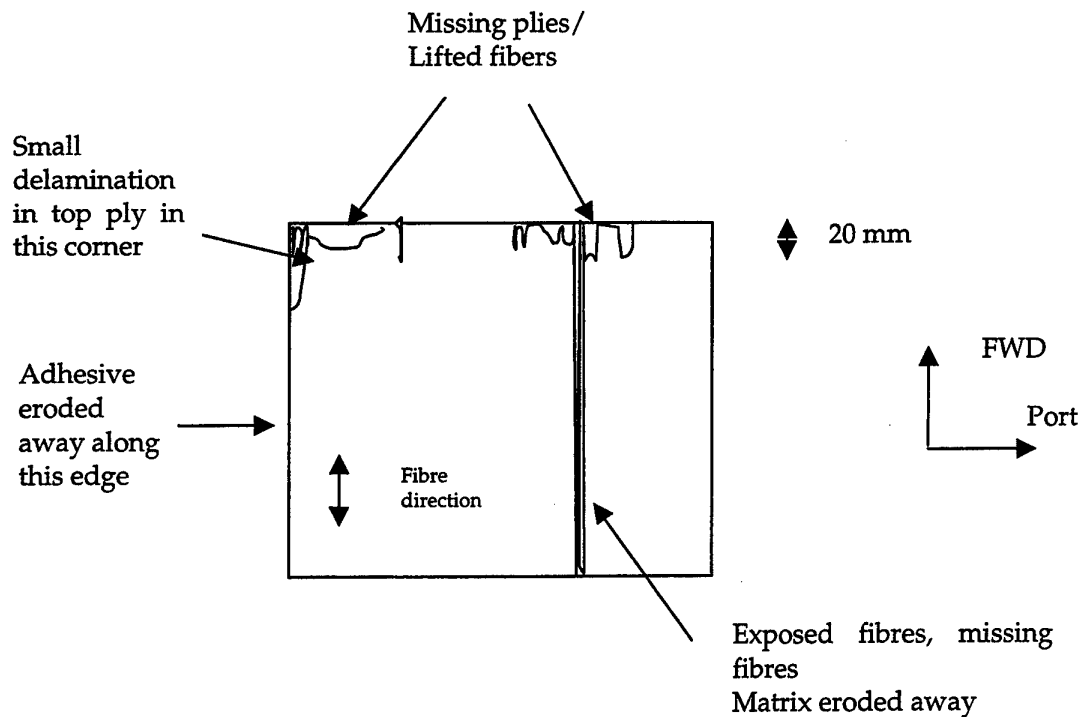
Figure 5. Damage map of location 'f'

The repair at this location showed significant signs of erosion, mainly to the leading edge. There was significant fiber-tear out along the length of the repair in the top ply (Figure 5, photo 4). Many loose fibres were present, which were removed for safety reasons during the inspection. There were signs of a small delamination in the corner of the repair between the outer layer and the second layer. Bond integrity was excellent with no other abnormalities detected during the tap test.

The repair at location 'f', on the lower surface of the stabiliser was more sheltered from debris and FOD than the repair on the top surface 'g', already described above, and hence saw less damage.

6. The demonstrator repair at location 'f' should either be removed or a protective sheath installed over it to trial an erosion protection system.

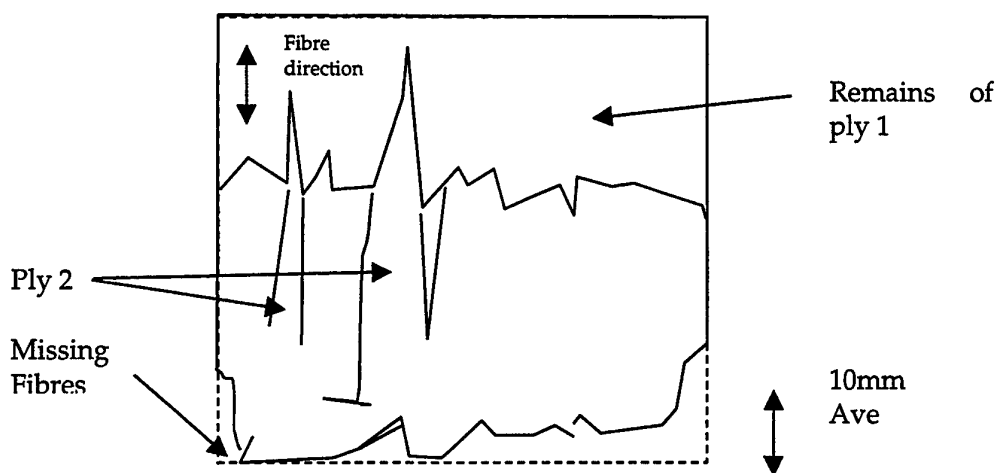
Significant erosion of this repair had occurred. Despite being painted over many times (Photo 6), indications were that up to 60% of the top ply, 10% of the second ply and approximately 5% of the third ply had eroded away. In the region 0 to 10mm from the leading edge, most of the fibres had eroded away over the width of the repair. In the areas where the repair had eroded away, the primer and grit blast surface had also been removed leaving a bare aluminium surface.

In one region, approximately 3mm x 3mm, the adhesive had eroded away from between the aluminium and the boron (Figure 6), leaving the fibres free. The remainder of the repair had excellent bond integrity.

*Figure 6. Damage map of region 'g' showing extent of ply stripping and damage due to erosion.*

The repair 'g', on the top surface of the stabiliser, was in line with the exhaust gas path of the number 2 engine. During takeoff and landing, with the aircraft in a nose high position, the exhaust gases ricochet off the runway and will carry any loose material up at high velocity towards the horizontal stabiliser.

The top surface of the stabiliser is more exposed than the lower surface while the aircraft is in this flight condition. This is due to the negative trim setting angle of the stabiliser which leaves the leading edge of the stabiliser rotated downwards with respect to the trailing edge, exposing more of the top surface than the lower surface to direct airflow.
